**PRECIPITATION STATIC ELECTRICITY AND
SWEPT-STROKE LIGHTNING EFFECTS ON
AIRCRAFT TRANSPARENCY COATINGS**

R.C. Twomey
Douglas Aircraft Company
McDonnell Douglas Corporation
3855 Lakewood Boulevard
Long Beach, California 90846

DECEMBER 1977

TECHNICAL REPORT AFFDL-TR-77-141

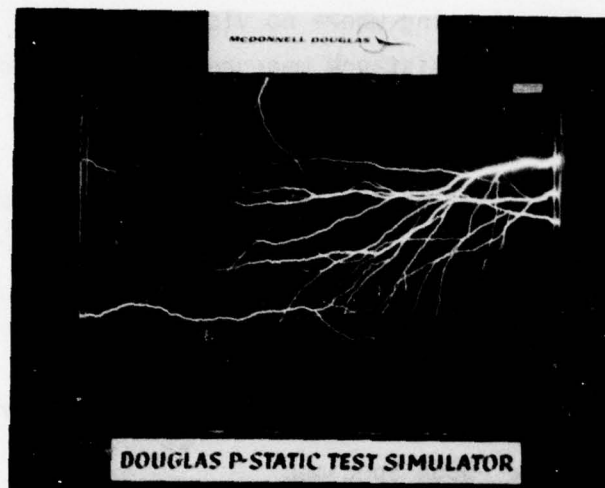
Figure 13. Multiple Exposure Discharges on -505A Specimen.

The same procedure, as previously described, was used to conduct the assessment after the second static electric discharge exposure run. Visual, resistance, and Thermovision inspections disclosed no significant changes. Isotherm traces from the Thermovision color photographs for the baseline,

first exposure, and second exposure thermographs are shown in Figure 14. Note that the isotherm lines on the traces do not represent the same temperature for each Thermovision run. The important, easily derived information from the traces is that no significant change in the heating pattern took place. This observation translates to the conclusion that a large number of surface flashes apparently did not induce damaging current into the gold conductive coating of the -505A specimen.

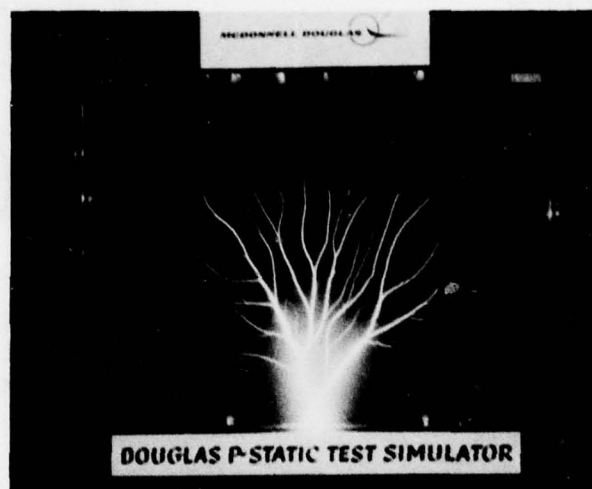
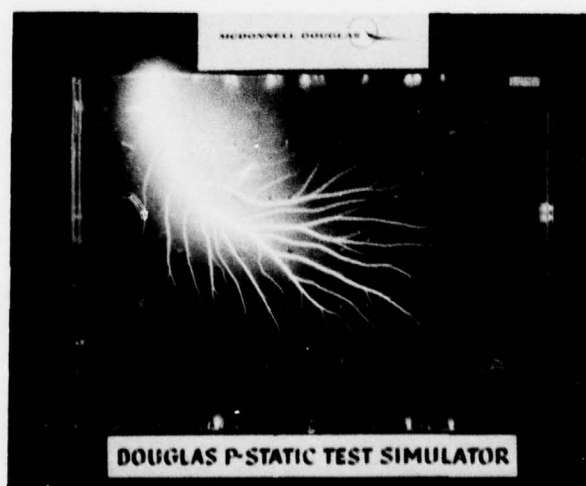
Figure 15. Surface Discharges During First Exposure Run on -1A Specimen.

The visual inspection yielded no indication of damage. Resistance measurements (Table I) also indicated no significant change. The Thermovision inspection did show a change in the two little areas of warmer temperature discussed under "Initial Thermovision Measurements" on Page 23. They appeared to be more accentuated and the central cores were of a slightly higher relative temperature. Isotherm traces similar to those previously discussed for Figure 14 are presented for the -1A specimen in Figure 16.

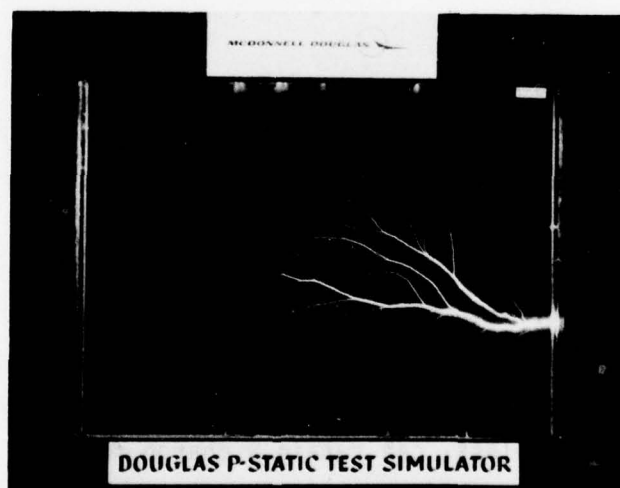
Figure 17. Surface Discharges During Second Exposure Run on -1A Specimen.

Sixty-five additional surface flashes were allowed during the second run for a grand total of 124 flashes. This compares with a total of 163 flashes on the -505A specimen. A photograph of one of the second run surface flashes is shown in Figure 17.

Visual inspection showed no signs of damage. Resistance measurements also indicated no change (Table 1). The Thermovision inspection did show progressive changes in the two areas previously noted. Apparently there was

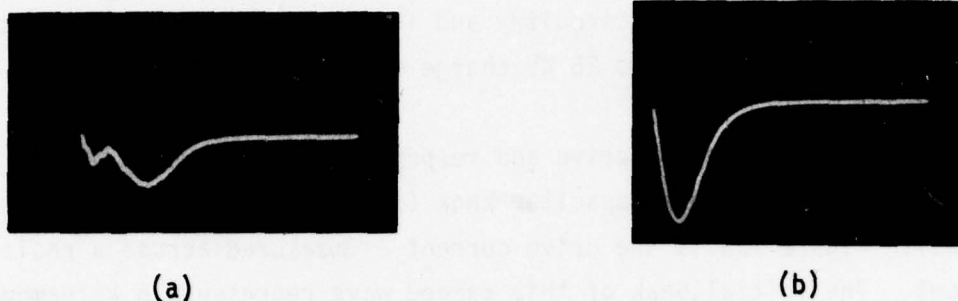
Figure 18. Oscilloscope Trace of Current in Conductive Coating in -1A During Surface Discharge.

The discharge current in the ground circuit of the conductive coating was measured, as described in Section II, Page 7. Some difficulty was experienced in obtaining good oscilloscope traces. This was partly due to the elusive timing of the discharge, and partly due to insufficient shielding in the test setup to eliminate false oscilloscope triggering caused by the ambient electromagnetic interference. It was not practicable to correlate a photograph of the discharge flash with the oscilloscope trace of the current in the conductive coating. Figure 18A is a trace of a flash which apparently was several microseconds in forming, as evidenced by the double hump. It is also possible that this represents two nearly coincident smaller discharges. Figure 18B is a very clean picture of one larger flash. The reduced scan mode of the Tektronix 466 storage oscilloscope was used for these measurements. The smaller graticule divisions are to be used in interpreting these traces. The peak amplitude of Figure 18B represents about 100 amperes with a rise time in about 1 microsecond.

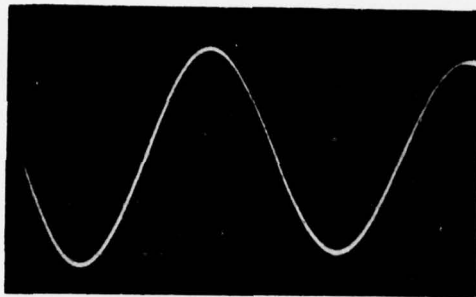
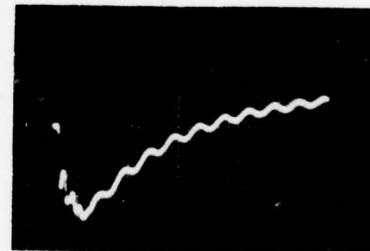
Figure 19. Lightning Drive and Response Waveforms in -1B Specimen.

Figure 19 is a series of drive and response waveforms run at 25 KV charge on a 0.54-microfarad capacitor bank (four 2 microfarad capacitors in series). Figure 19a is the drive current as measured across a resistive shunt. The initial peak of this damped wave represents 8 kiloamperes. Figure 19b is a detailed study of the early time characteristics of the waveform of Figure 19a. Figure 19a is at 2 microseconds per division, while Figure 19b is at 0.05-microsecond per division. The vertical response of Figure 19b is 2.5 times as sensitive as for Figure 19a, and indicates a clean front end structure. Figure 19c is a trace of the response signal in the bus-to-bus current flowing in the -1B specimen. It was measured using the Stoddart 91550-1 current probe around the wire which interconnected the buses. Figure 19c is to the same time scale as Figure 19a (2 μ sec./div) and shows that for time beyond the initial induced transient, the waveform has the same frequency as the drive current. Note that with the exception of Figure 19a, all the other Figure 19 traces used the reduced scan feature of the 466 oscilloscope wherein the small graticule squares apply.

Figure 19d is a detailed study of the fast time characteristics of the waveform of Figure 19c. Figure 19d was taken at the same vertical sensitivity as Figure 19c, but at 0.2-microsecond per division. The transfer impedance of the Stoddart current probe is higher for high frequencies than for low frequencies. Therefore, the amplitude of the initial, fast rising (negative going) transient in Figure 19b represents 41 amperes, while the first positive peak of the lower frequency portion of the wave represents 36 amperes.

(a) Lightning drive
 $2 \mu \text{ sec/div}$
 8K amp first peak
 (3.56K A/Div)
 (Large graticule squares)

(c) Response in conductive
 coating from excitation
 of (a) above.
 $2 \mu \text{ sec/div}$
 first negative peak $\cong 41\text{A}$
 first positive peak $\cong 36\text{A}$.

(d) Early time characteristics
 of (c) $0.2 \mu \text{ sec/div}$
 same vertical sensitivity
 as (b)

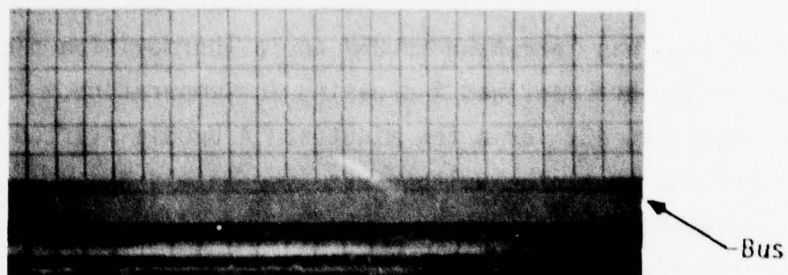
(a) Photo of undamaged coating/bus interface area.
